Wetland Delineation Report

Industrial Site

Black River Falls, Wisconsin

BES Project No. 2016.035

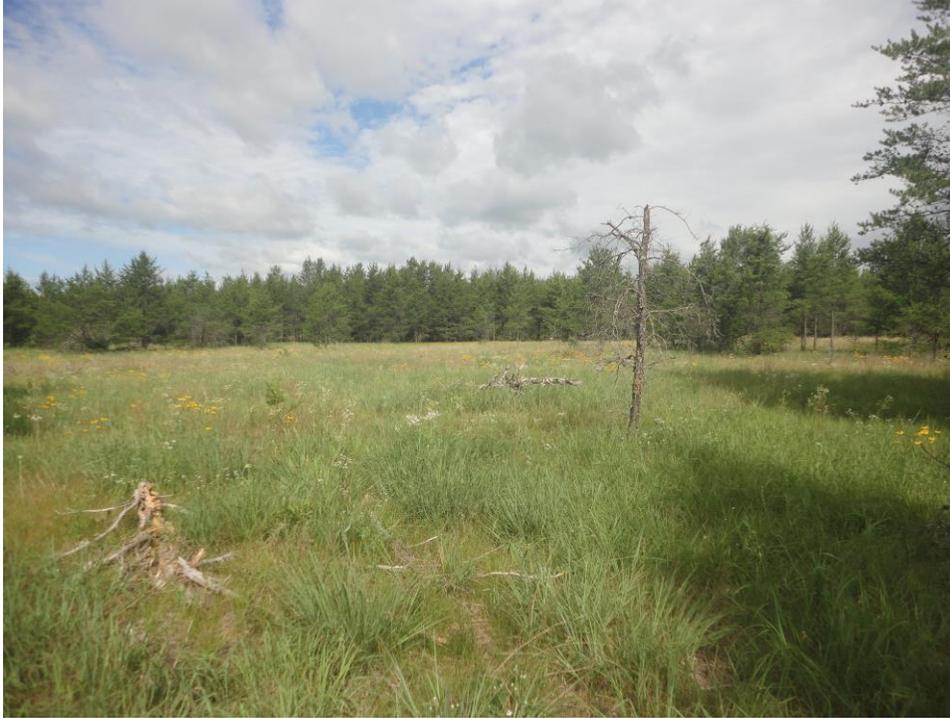
Typical view of the prairie openings in the Jack pine forest on the western 2/3rd of the site.

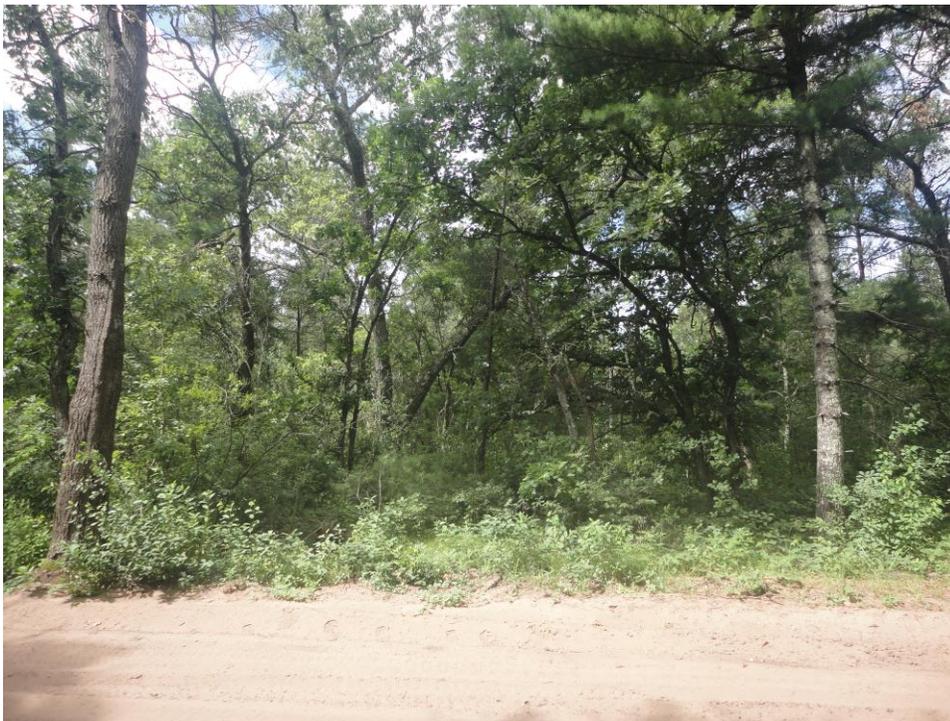
Typical view of the white pine and red oak forest on the eastern 1/3rd of the site.

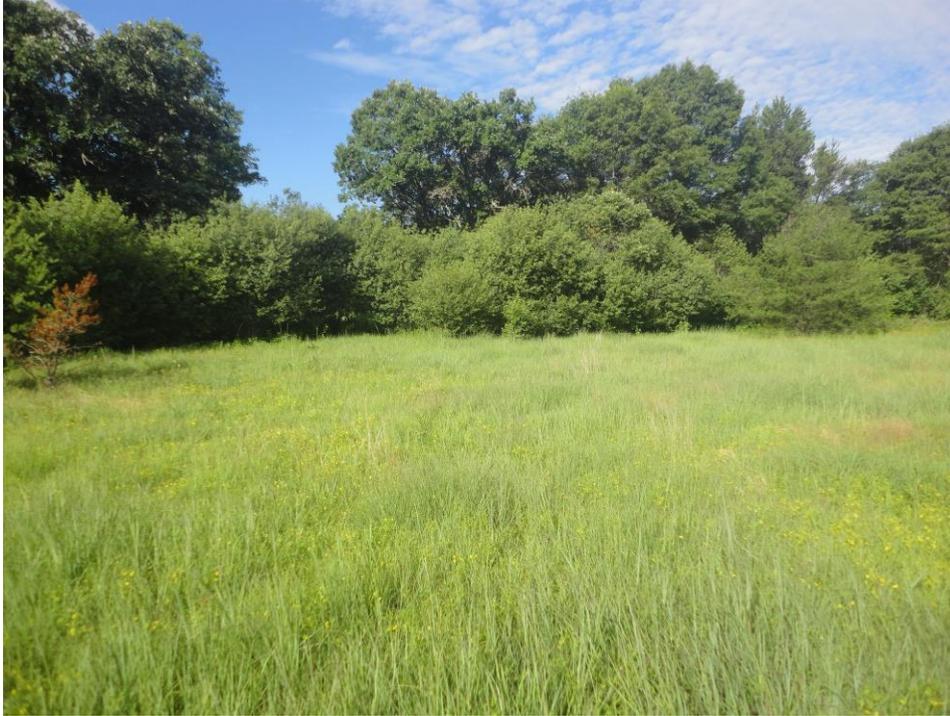
Sample point SP-1 is in an opening in the forest, at the head of a broad swale that crosses the site from north to south in the eastern 1/3 of the site. This swale is identified on the WWI as an indicator soil map unit. The vegetation is dominated by little bluestem grass (*Schizachyrium scoparium*), spotted St. Johns-Wort (*Hypericum punctatum*) and witch grass (*Panicum capillare*). The plant community met the dominance test but had a prevalence index of 3.37. Two of the three dominant species were FAC and the vegetation did not meet the FAC-neutral test for hydrology. The SP-1 soil profile consisted of eight inches of 10YR 2/1 sand, over seven inches of 10YR 4/2 sand, over 5YR 3/1 sand. There were no redoximorphic features observed in the soil profile. The water table and saturated soil was not observed within a depth of 25 inches in the soil pit at the time of the site visit. The geomorphic position (D2) hydrology indicator is not considered applicable because the area is not wet long/often enough to develop hydric soils. Because the area did not meet the hydric soils and wetland hydrology criteria BES concluded it was not jurisdictional wetland.

Sample Point SP-1 looking south. This is a grassy opening in the forest at the north end of a broad swale that crosses the eastern 1/3rd of the site.

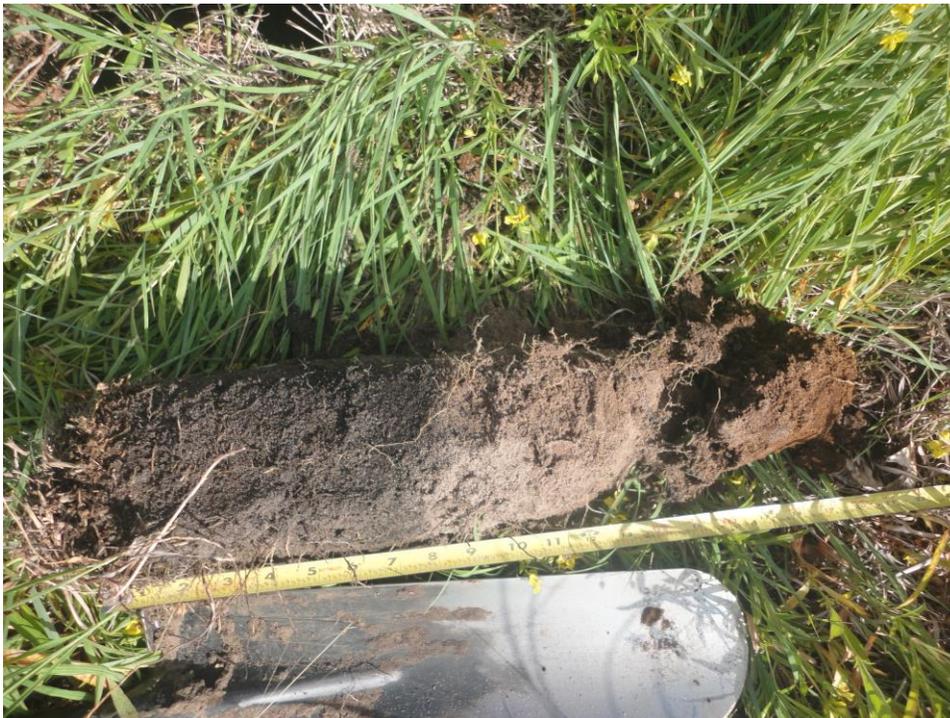
SP-1 soil profile is a spodosol that lacks redoximorphic features.

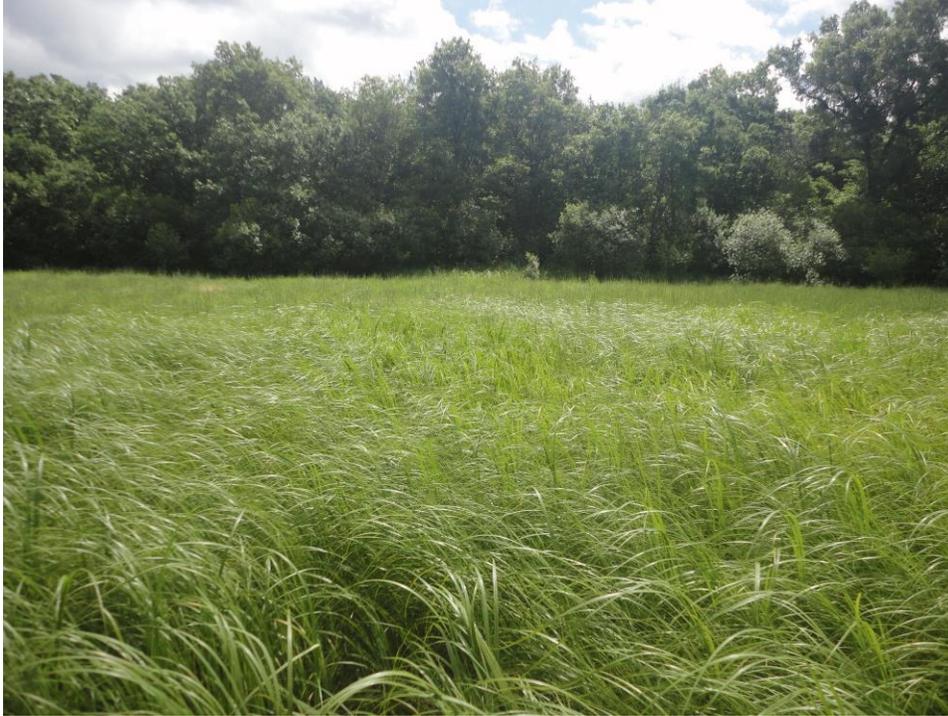
Sample point SP-2 is an opening in the forest, in the same broad swale and just south of SP-1. SP-2 was sampled in the landscape position that appeared to be the wettest part of the opening. The majority of the opening was similar to SP-1. The vegetation at SP-2 is dominated by mossy cup oak (*Quercus macrocarpa*), common buckthorn (*Rhamnus cathartica*), red oak (*Quercus rubra*), white oak (*Quercus alba*), prairie cord grass (*Spartina pectinate*) and dewberry (*Rubus flagellaris*). The plant community did not meet the dominance test but had a prevalence index of 2.79. The soil profile consisted of six inches of 10YR 2/1 sand, over four inches of 10YR 5/1 sand, over seven inches of 5YR 3/3 sand, over 7.5YR 3/4 sand. There were no redoximorphic features observed in the soil profile. The water table and soil saturation was not

observed within a depth of 26 inches in the soil pit at the time of the site visit. There were no other wetland hydrology indicators that were observed in the area. The geomorphic position (D2) hydrology indicator is not considered applicable because the area is not wet long/often enough to develop hydric soils. The plant community also did not meet the FAC Neutral test. Of seven readily available aerial photos (**Appendix B**), only one showed evidence of wetland conditions and that photo was an early spring 1999 photo in a month that received almost 200% of average precipitation. Because the area did not meet hydric soils and wetland hydrology criteria BES concluded it was not a jurisdictional wetland.

Sample Point SP-2 looking east across the grassy opening in the forest. This basin is in the same broad swale and just south of SP-1.

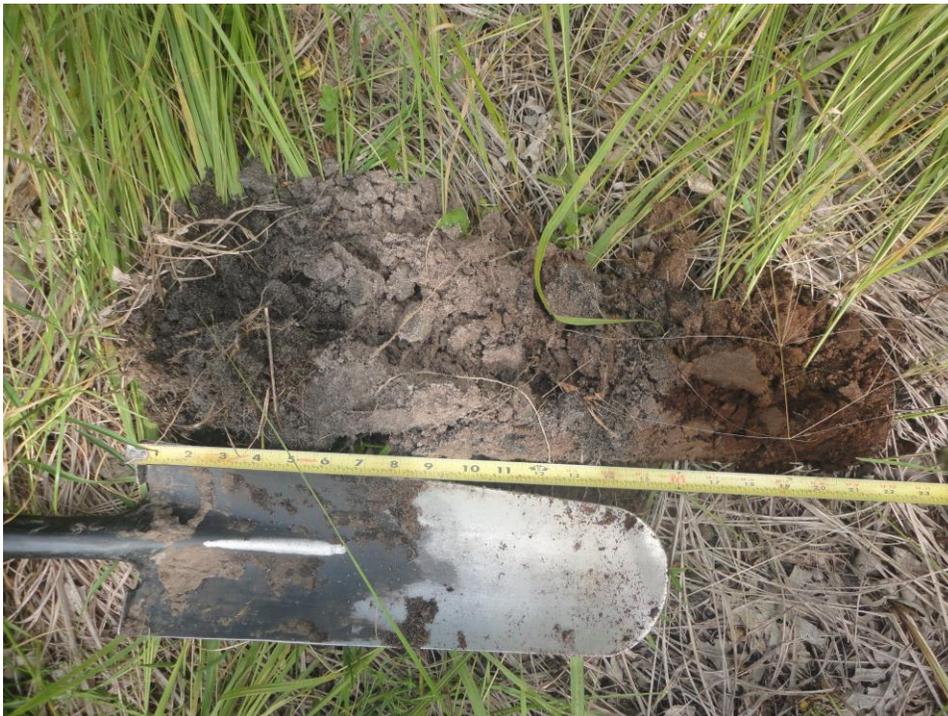
SP-2 soil profile. The soil is a spodosol with no redoximorphic features.

Remarks:
 soil is a spodosol. No redox features observed.

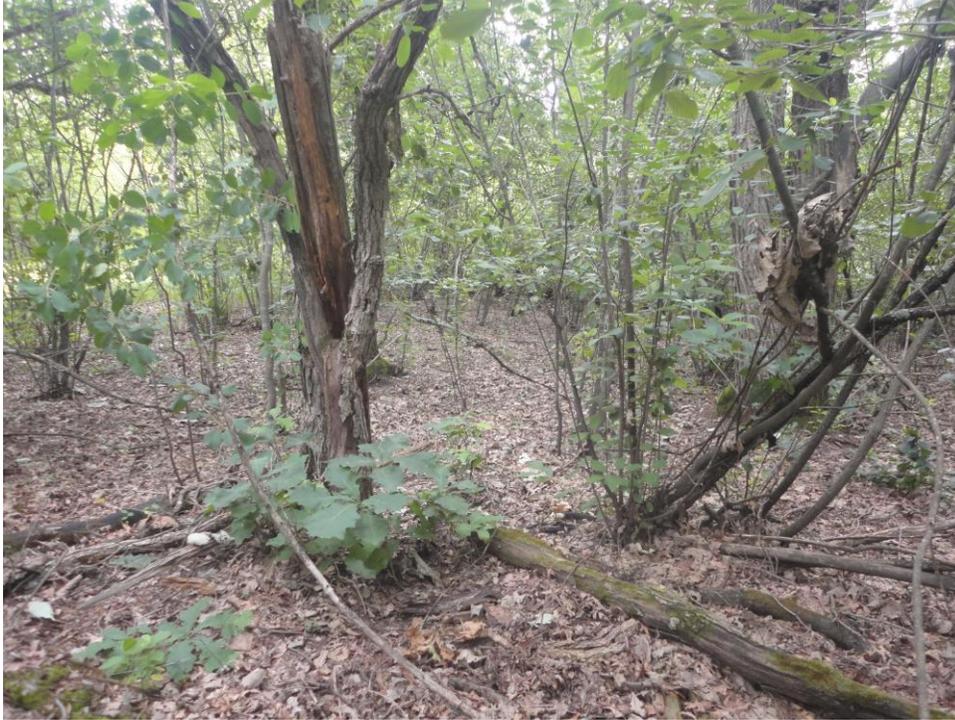
Sample point SP-3 is in the forest, in the same broad swale and just south of SP-2. The vegetation at SP-3 is dominated by mossy cup oak, red oak, common buckthorn, and dewberry. Unlike the forest surrounding the swale, there was virtually no herbaceous layer in the plant community. The plant community did not meet the dominance test and had a prevalence index of 3.87. The soil profile consisted of five inches of N 2/0 sand, over four inches of 10YR 2/1 sand, over seven inches of 10YR 3/3 sand, over 7.5YR 3/4 sand. There were no redoximorphic features observed in the soil profile. The water table and soil saturation was not observed within a depth of 28 inches in the soil pit at the time of the site visit. There were no other wetland hydrology indicators that were observed in the area. The geomorphic position (D2) hydrology indicator is not considered applicable because the area is not wet long/often enough to develop hydric soils. The plant community also did not meet the FAC Neutral test. The area is not a sparsely vegetated concave surface because even though there are few herbaceous plants there are a lot of trees and shrubs in the area. Because the area did not meet hydric soils, hydrophytic vegetation and wetland hydrology criteria BES concluded it was not a jurisdictional wetland.

Sample point SP-3 looking north. This sample point is in the same broad swale and just south of the opening with SP-2. The swale generally has sparse understory vegetation as compared to the adjacent forested areas of the site.

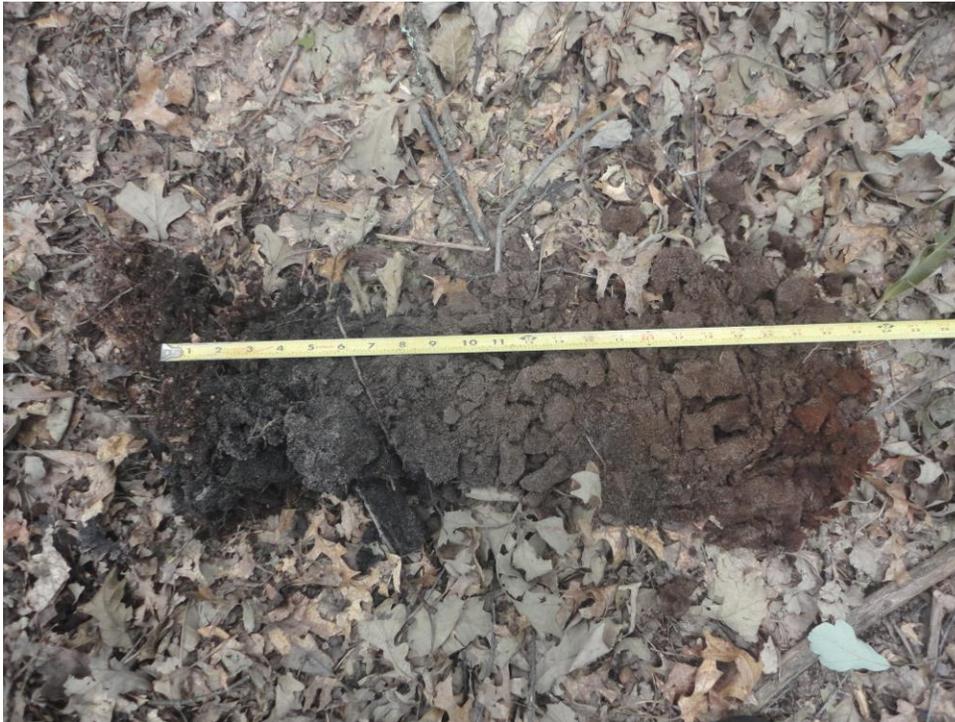
SP-3 soil profile. The soil is still a Spodosol. The surface is getting darker, but there still are no redoximorphic features in the soil profile.

Remarks:
 no redox features. Surface is not dark/deep enough and there is no depleted matrix with depth for A12.

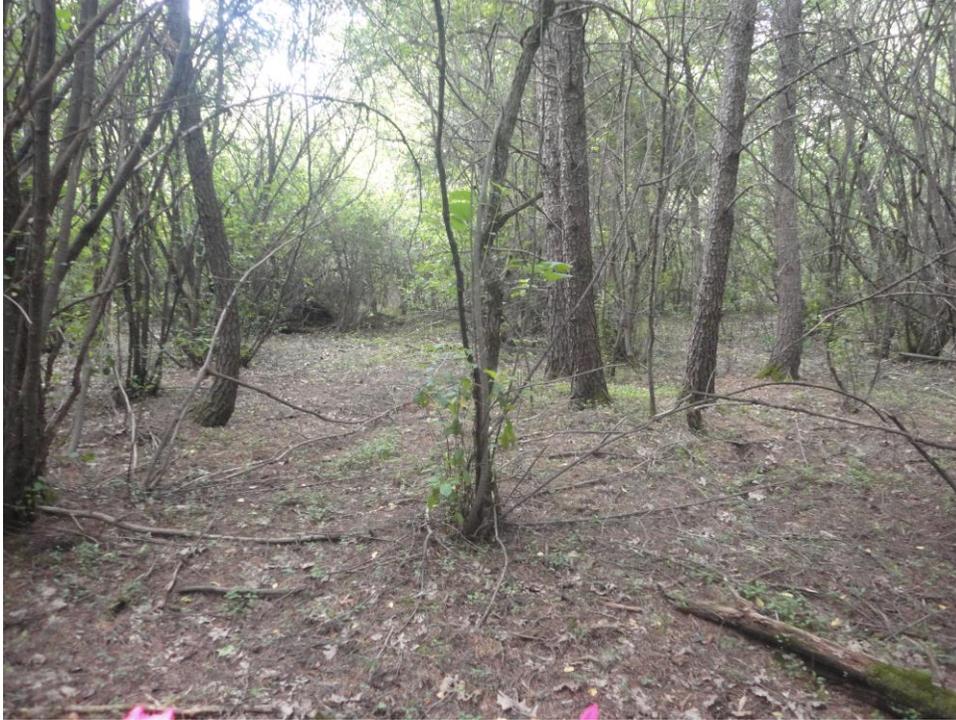
Sample point SP-4 is in the forest, in the same broad swale and just south of SP-3. The area was evaluated because the overstory was different from SP-3. The vegetation at SP-4 is dominated by jack pine (*Pinus banksiana*), mossy cup oak and common buckthorn. Unlike the forest surrounding the swale, there was virtually no herbaceous layer in the plant community. The plant community did not meet the dominance test and had a prevalence index of 3.48. The soil profile consisted of five inches of 10YR 2/1 sand, over seven inches of 10YR 5/1 sand, over ten inches of 7.5YR 3/3 sand, over 10YR 4/2 sand. There were no redoximorphic features observed in the soil profile. The water table and soil saturation was not observed within a depth of 30 inches in the soil pit at the time of the site visit. There were no other wetland hydrology indicators that were observed in the area. The geomorphic position (D2) hydrology indicator is not considered applicable because the area is not wet long/often enough to develop hydric soils. The plant community also did not meet the FAC Neutral test. The area is not a sparsely vegetated concave surface because even though there are few herbaceous plants there are a

lot of trees and shrubs in the area. Because the area did not meet hydric soils, hydrophytic vegetation and wetland hydrology criteria BES concluded it was not a jurisdictional wetland.

Sample point SP-4 looking west. This sample point is similar to SP-3 but further south in the broad swale.

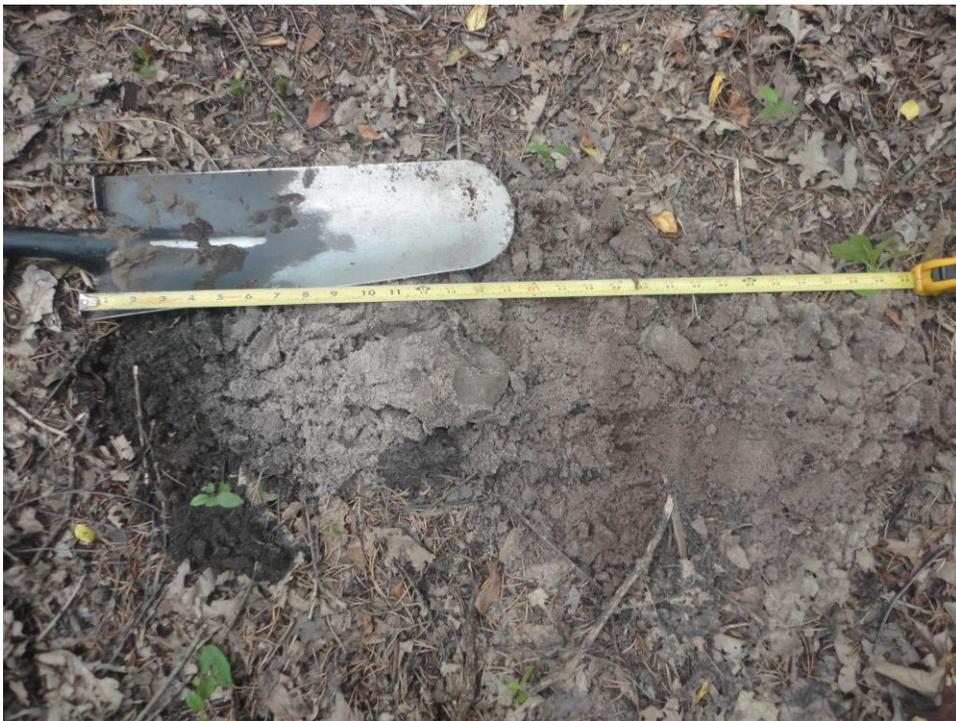
The SP-4 soil profile is an Inceptisol. The soil did not meet the depleted matrix criteria and did not have a mucky/peaty surface, a splotchy pattern or organic coating on the sand grains.

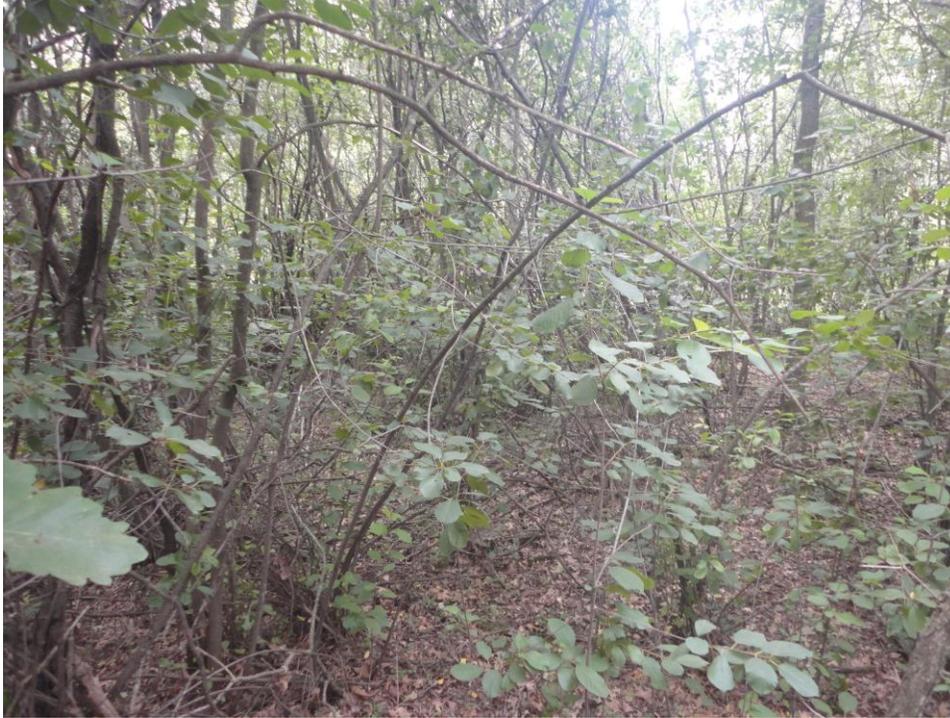
Sample point SP-5 is in the forest, in the same broad swale and at the south boundary of the site. The area was evaluated to document if potential wetlands encroached on to the site. The vegetation at SP-5 is dominated by red oak, swamp white oak (*Quercus bicolor*) and common buckthorn. Unlike the forest surrounding the swale, there was virtually no herbaceous layer in the plant community. The plant community did meet the dominance test but had a prevalence index of 3.23. The soil profile consisted of five inches of 10YR 2/1 sand, over nine inches of 5YR 5/1 sand, over 10YR 7/2 sand. The soil did not have a splotchy soil matrix but both of the lower horizons met the depleted matrix criteria. The water table and soil saturation was not observed within a depth of 30 inches in the soil pit at the time of the site visit. The geomorphic position (D2) hydrology indicator is applicable because the area is in a concave position and has a hydric soil. The plant community did not meet the FAC Neutral test. The area is not a sparsely vegetated concave surface because even though there are few herbaceous plants there are a lot of trees and shrubs in the area. Because the area only had one wetland hydrology indicator BES concluded it was not a jurisdictional wetland.

Sample point SP-5 is further south in the broad swale and just outside the site boundary. Further off-site there is an excavated, open water basin in the broad swale but it doesn't extend north to the site.

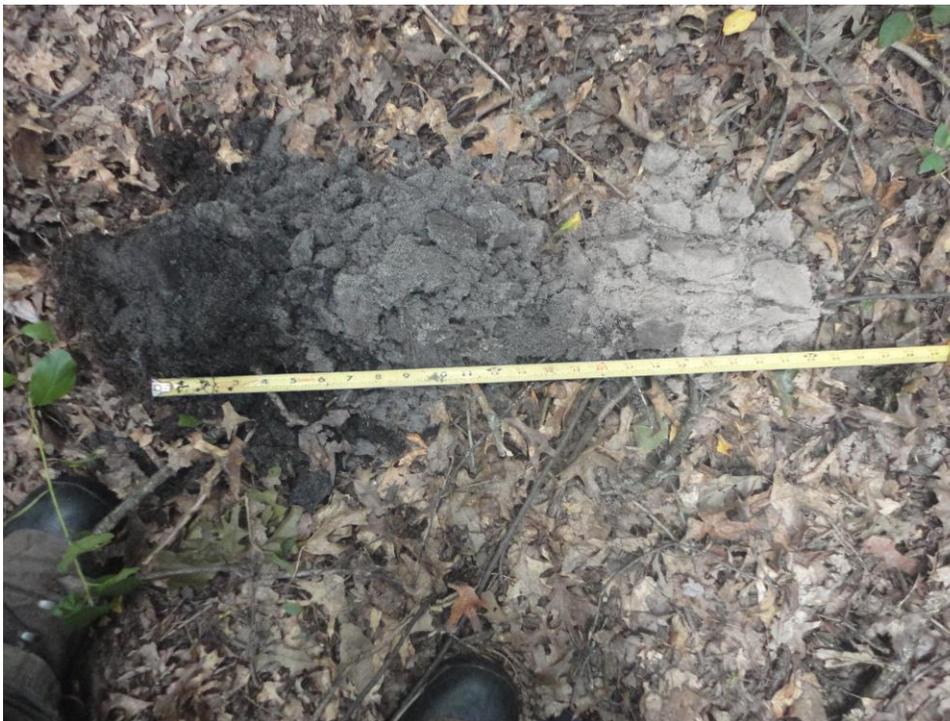
SP-5 soil profile is an Inceptisol. The soil did meet the depleted matrix criteria (A11) but did not have a mucky/peaty surface, a splotchy pattern or organic coating on the sand grains.
