Wetland Delineation Report

Prescott Eagle Ridge Business Park

Prepared for: Cedar Corporation

Prescott, Wisconsin

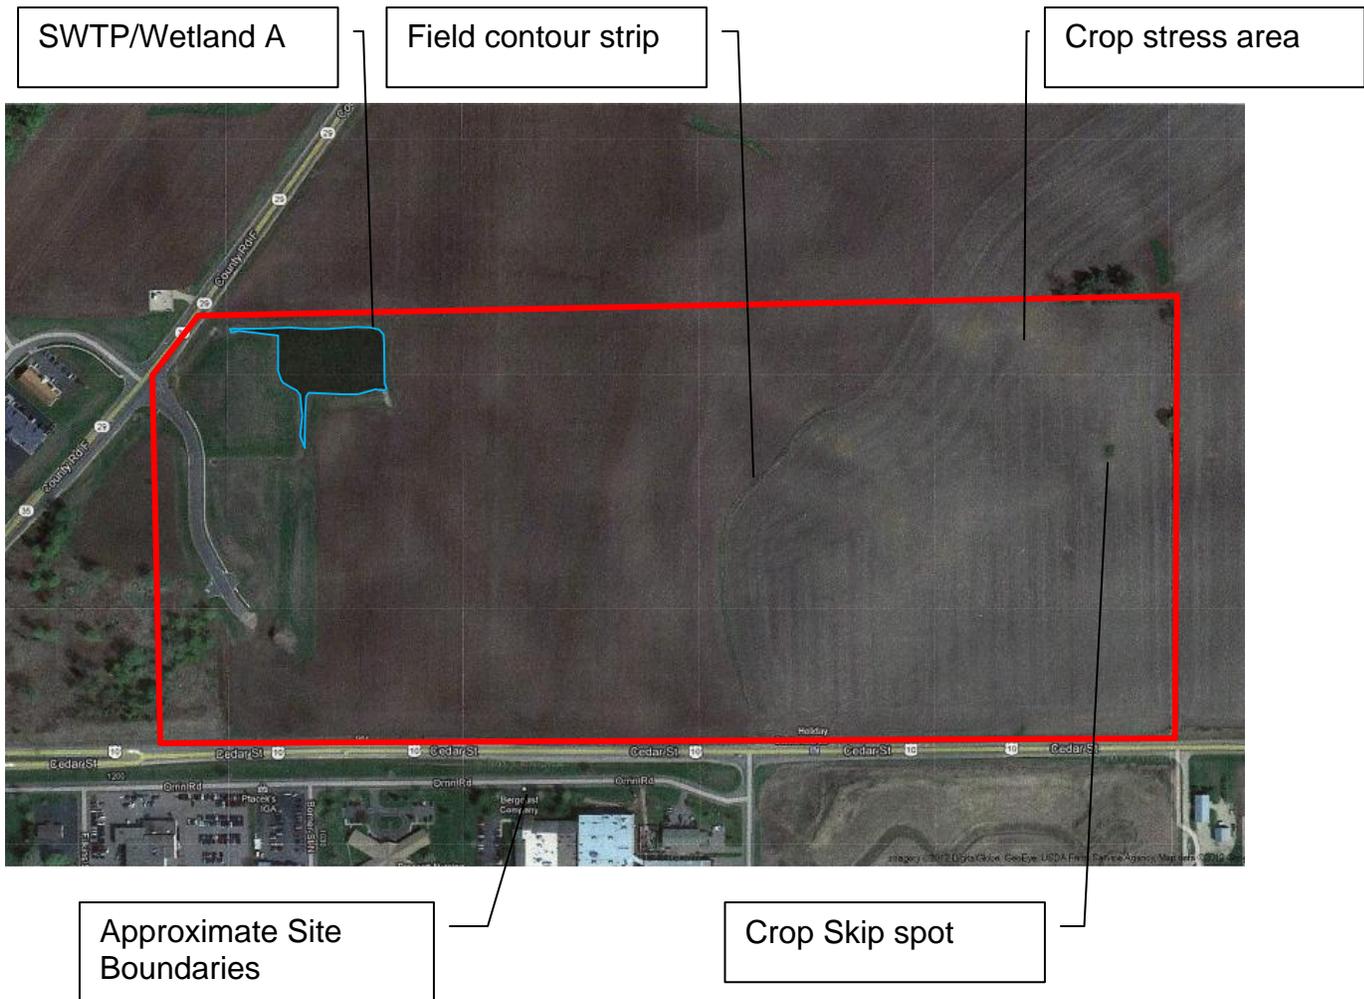
**Figure 3. Aerial Photo With
Approximate Wetland Boundaries**
Prescott Eagle Ridge Business Park
Prescott, Wisconsin

This pond is located in the northwest part of the site and was not present in the 2010 aerial but was evident in the 2011 aerial photo. Wetland A is shallow open water, mud bottom, Palustrine, excavated basin (W3Hx, PUBFx) with a narrow shallow marsh fringe. The wetland edge (sample point SA-1) is dominated by sandbar willow (*Salix interior*), black willow (*Salix nigra*), crack willow (*Salix fragilis*), eastern cottonwood (*Populus deltoids*), saw tooth sunflower (*Helianthus grosseserratus*), barnyard grass (*Echinochloa crus-galli*) and Kentucky bluegrass (*Poa pratensis*). The wetland soils consisted of more than 16 inches of mixed 10YR 2/1, 10YR 4/2 and 10YR 4/1 sandy loam fill material. The wetland hydrology indicators observed in the wetland included surface water (A1) and a positive FAC-neutral test (D5). Water or saturated soil was not observed in the soil pit even though it was only 12 inches from the surface water and below the water level. The adjacent upland vegetation (sample point SA-2) is dominated by white sweet clover (*Melilotus alba*), yellow foxtail grass (*Setaria faberi*) and alfalfa (*Medicago sativa*). The upland soils consisted of more than 14 inches of mixed 10YR 2/1, 10YR 2/2 and 10YR 3/3 sandy loam fill material. There was no free water or saturated soil in the upland soil pit at the time of the site visit. The wetland boundary was generally staked along a break in the topography and vegetation community.

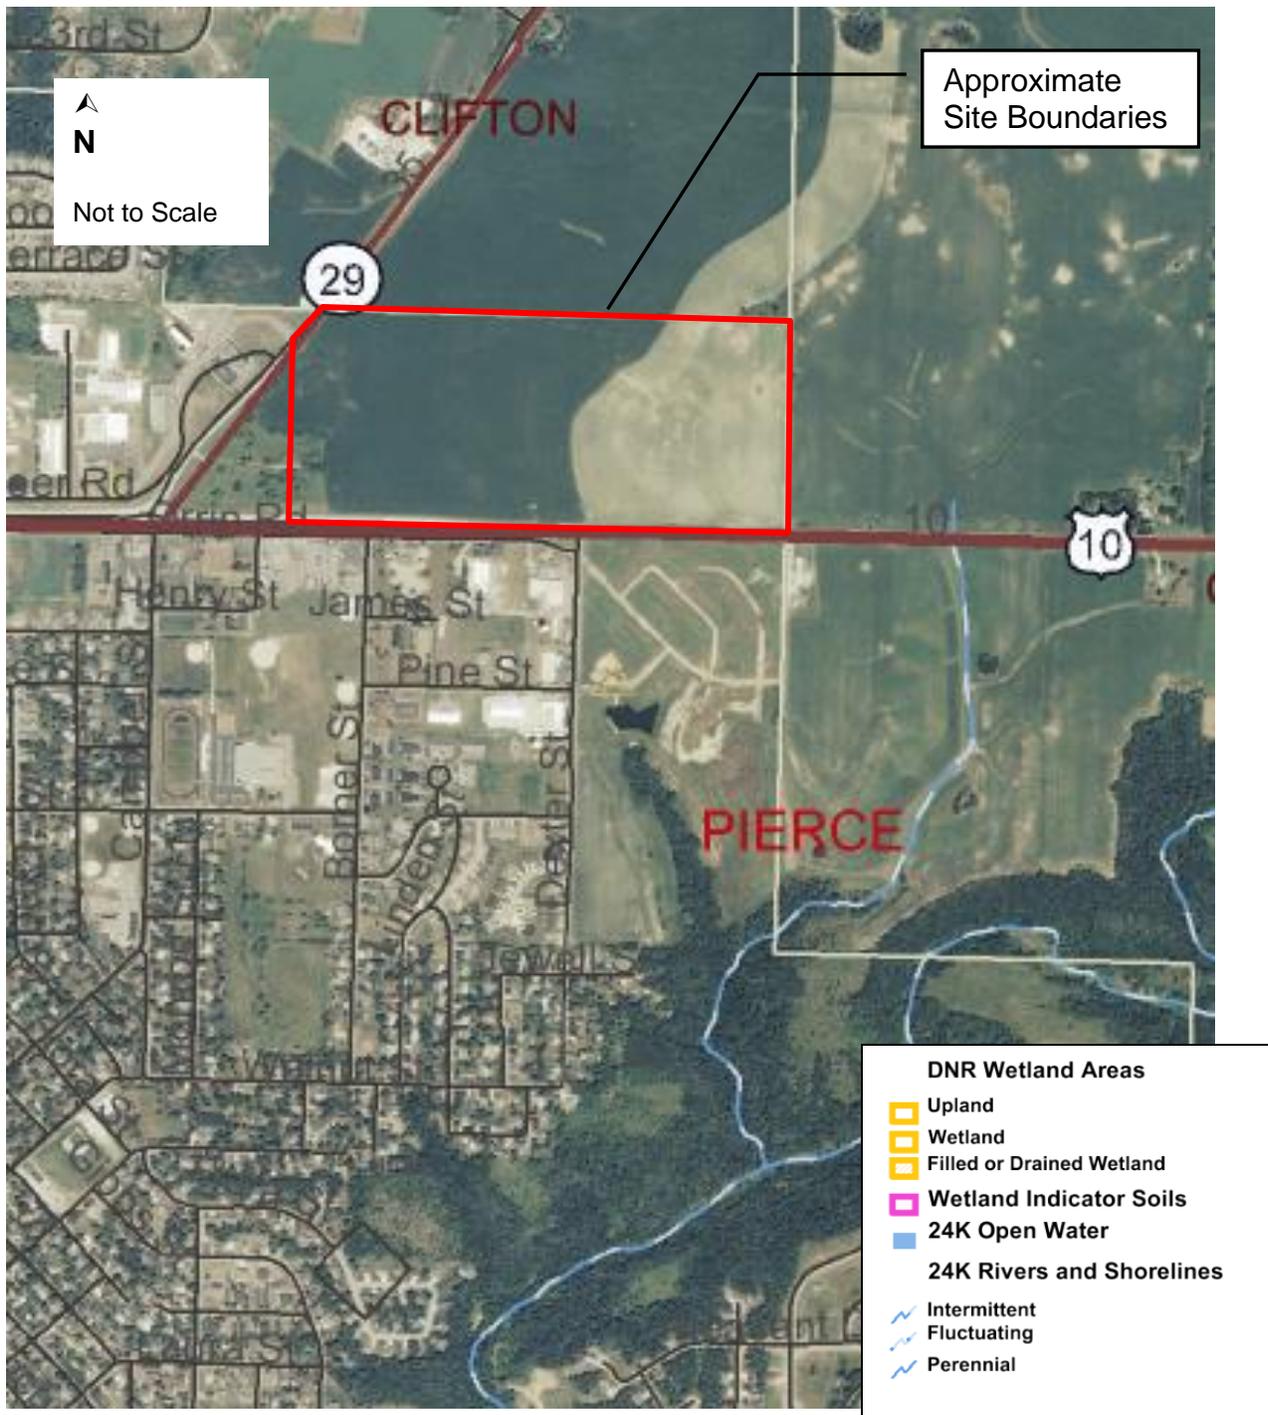
Figure 4. Wisconsin Wetland Inventory Map
 Prescott Eagle Ridge Business Park
 Prescott, Wisconsin

The Wisconsin Wetlands Inventory (WWI) (**Figure 4**) does not identify any wetlands or potential wetland area on the site. The Pierce County Soils Survey (**Figure 5**) shows the site is predominantly mapped as Dakota loam (401A), Rockton silt loam (170B), Wykoff loam (843C2), Vlasaty silt loam (816C2), Kasson silt loam (866B) and Lamont fine sandy loam (503B2) soil map units. All of these soil map units are listed as non-hydric soils. Several historical aerial photos were reviewed and the SWTP/Wetland A is not evident until 2011. The aerial photos showed consistent signatures of crop stress in the northeast corner of the site, and the linear features through the center of the site.

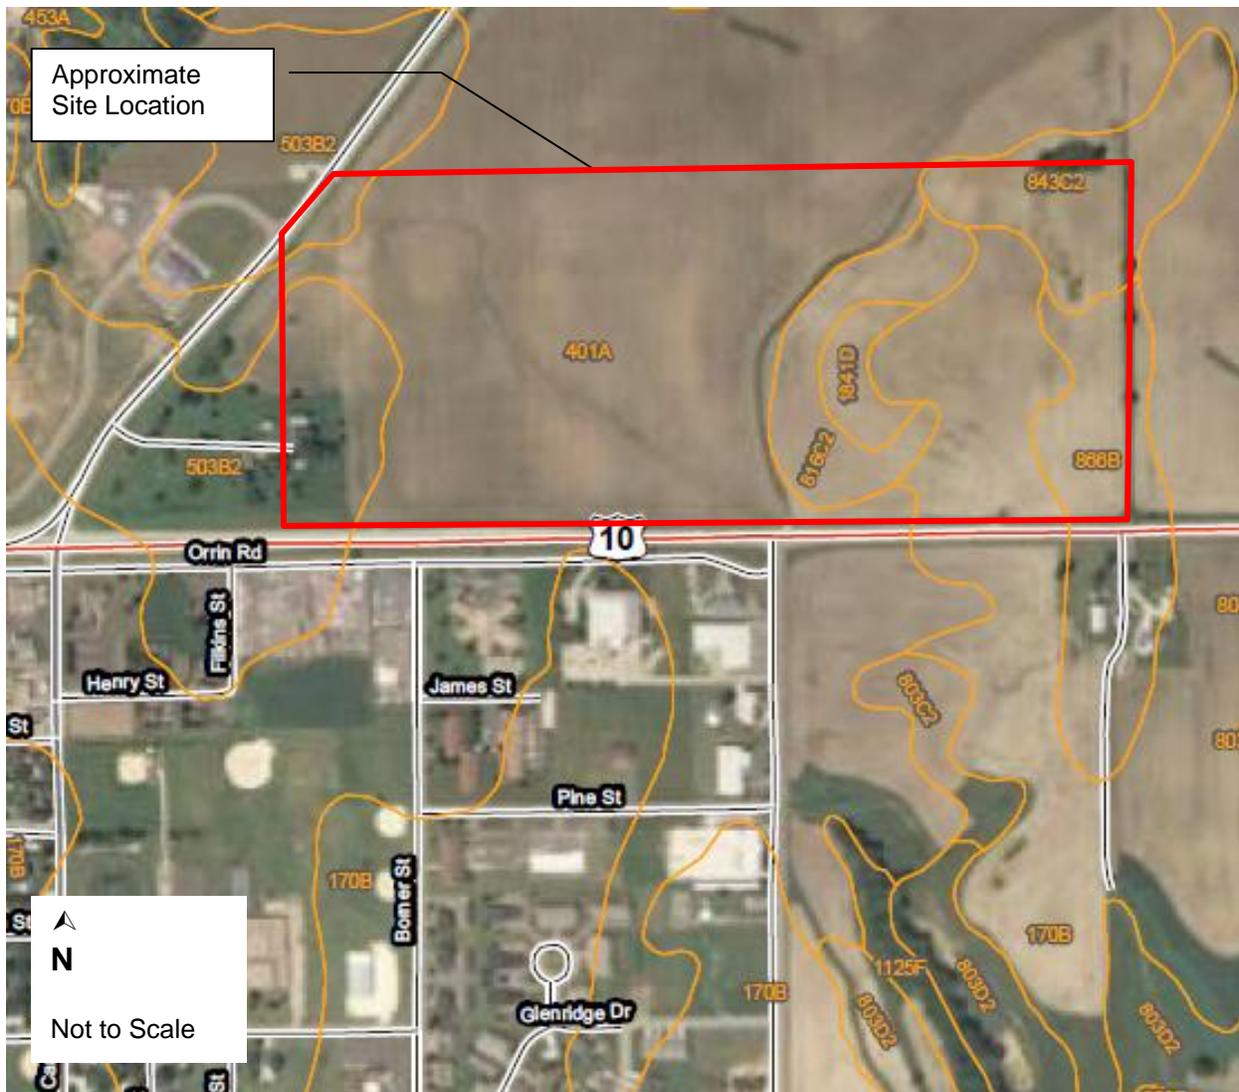
**Figure 5. Pierce County
Soil Survey Map**
Prescott Eagle Ridge Business Park
Prescott, Wisconsin

Soil Map Unit Legend	
170B	Rockton silt loam, strath terrace, 1-6% slopes, Non-Hydric
401A	Dakota loam, strath terrace, 0-3% slopes, Non-Hydric
503B2	Lamont fine sandy loam, 2-6% slopes, Non-Hydric
816C2	Vlasaty silt loam, dissected, 6-12% slopes, Non-Hydric
843C2	Wykoff loam, 6-12% slopes, Non-Hydric
866B	Kasson silt loam, 2-6% slopes, Non-Hydric
1841D	Lilah-Wykoff complex, 12-20% slopes, Non-Hydric

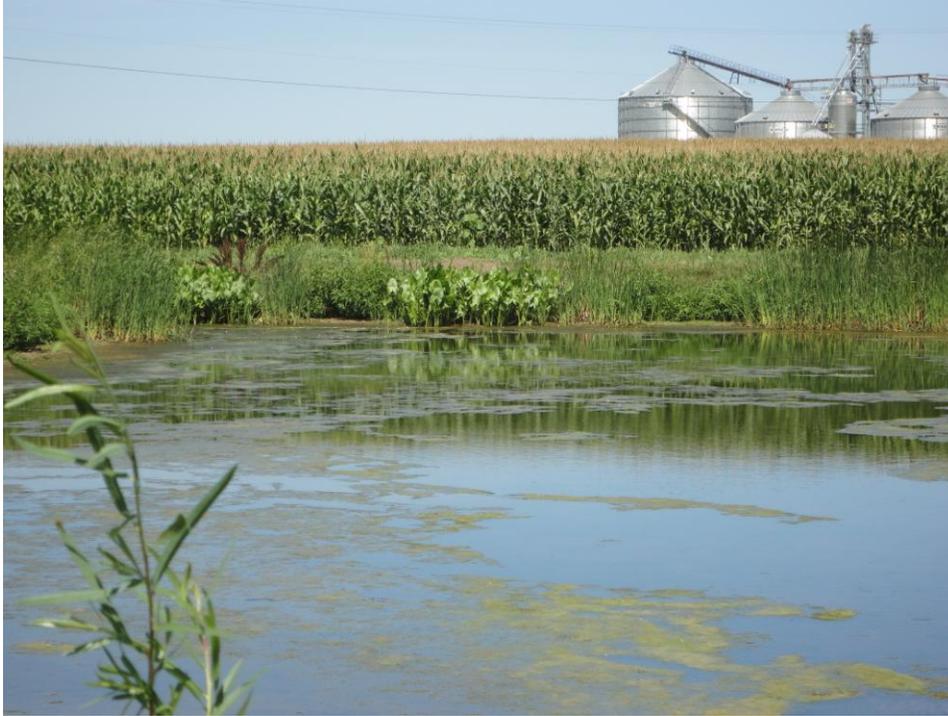
The stormwater treatment pond/Wetland A looking north. This pond was constructed in an upland area after 2010. It has taken on wetland characteristics but was clearly built for the purpose of treating stormwater from the surrounding development.

Table 1 indicates whether the wetlands are isolated or not for purposes of U.S. Army Corps of Engineers (COE) jurisdiction under Section 404 of the Clean Water Act. This determination is made by BES in the field at the time of the delineation and is essentially our best professional opinion based on the portion of the particular wetland we observed. In some cases, only a small portion of the wetland edge that is present on the property being delineated is evaluated. If no inlets or outlets are observed in the evaluated area, and none are evident on topographic maps or aerial photos, we are inclined to determine the wetland is isolated. However, since the entire wetland is sometimes not assessed, it is possible that inlets and/or outlets do exist and that the wetland has a surface connection to a federal "navigable" water and, thus, falls within the jurisdiction of Section 404. Therefore, a determination by BES of whether a particular wetland is isolated or not should not be considered a final determination with regard to COE jurisdiction until the COE concurs with the determination. The COE will likely **not** take jurisdiction over SWTP/Wetland A because it is clearly a recently excavated, stormwater

treatment pond constructed in an upland area that was not intended to create wetland conditions.

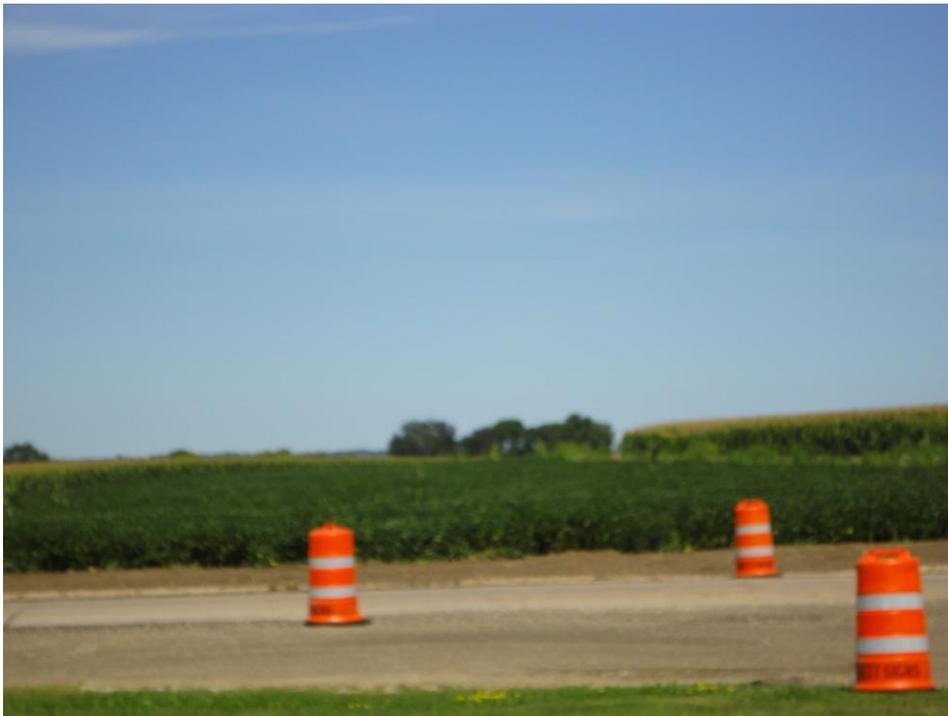
This is a soybean field on a contour strip, in the center of the site (looking north). The strip is evident in aerial photos and was investigated to confirm that it was not a wet grassed waterway. There was no evidence of a water way in the area.

The aerial photographs showed evidence of a linear feature through the central part of the site that extended from the south, off-site to the north. Often features like this are grassed waterways which can have wetland characteristics. On this site there was no waterway in the area but there was a conservation strip crop field with a small erosion control terrace. In 2012 the area was planted to soybeans (*Glycine max*) which showed no signs of crop stress due to wetness.

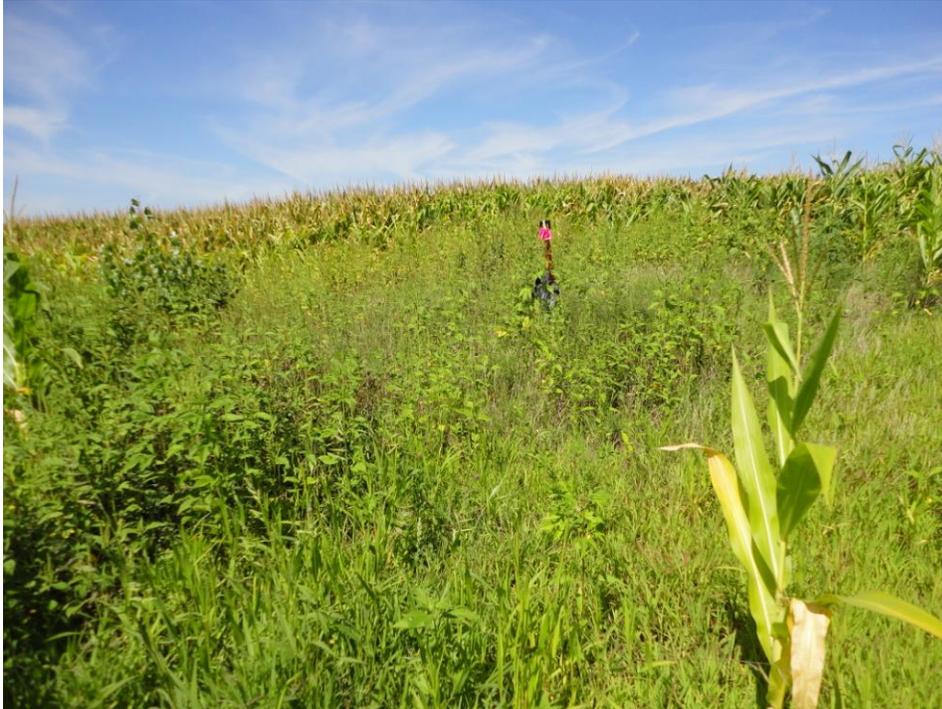
Area on the east side of the site that shows up on aerial photos consistently as not being farmed. The area is an extremely rocky area that shows no signs of being wet.

Aerial photographs identified a small area in the eastern part of the site where crop planting skipped nearly every year. This area was investigated (Data sheet SS) and determined not to have any wetland features. Corn (*Zea mize*) was planted all around this area in 2012 but this area was not tilled and planted. The skip spot is dominated by timothy grass (*Phleum pratense*) and Kentucky bluegrass. The sub-dominant species were also FACU and UPL species. The soils consisted of one inch of 10YR 3/3 sandy loam, over two inches 10YR 4/3 sandy loam, over 10YR 4/4 sandy clay loam. The soil was extremely rocky to the surface which is likely why the area is not cultivated. There was no free water or saturated soil in the upland soil pit at the time of the site visit. A few other locations in the northeast part of the site showed evidence of crop stress on aerial photos. In the field the crop stress was evident but appeared to also be related to extremely rocky and droughty soils and not a result of excess water.

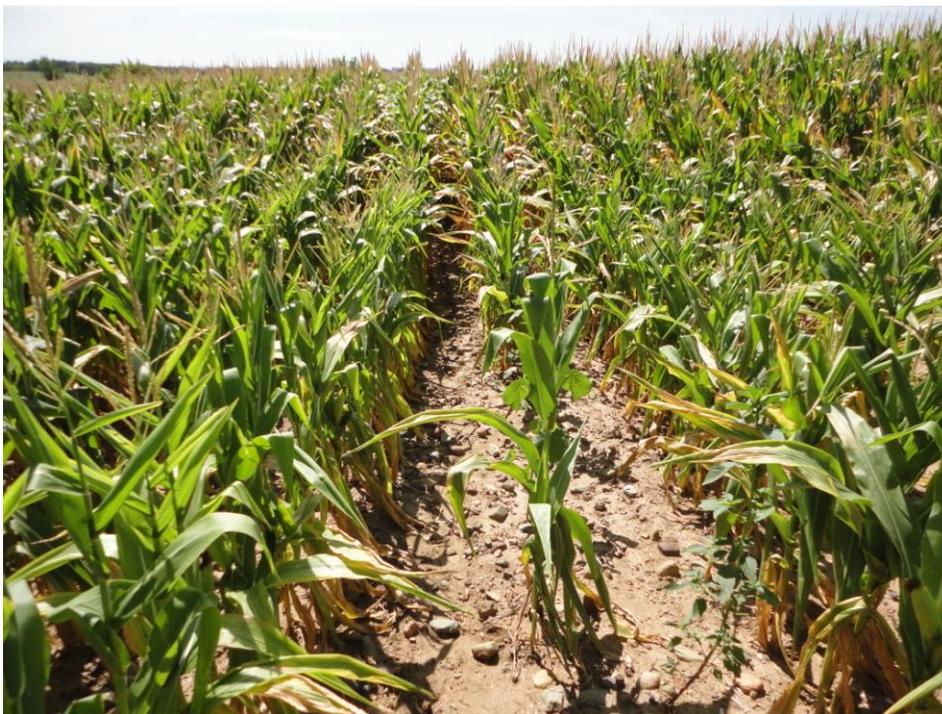
Stressed corn crop in the northeast part of the site. Aerial photos regularly show crop stress in this area of the site. The crop stress appears to be a result of extremely rocky and droughty soils. There was no evidence of wetness problems.
