Subject: Phase I Environmental Site Assessment  
Proposed Liberty Business Park – Verona  
6661 Whalen Road and 6620 CTH M  
Verona, Wisconsin  
MES Project No. 7-121033

**PHASE I ENVIRONMENTAL SITE ASSESSMENT**

**Proposed Liberty Business Park – Verona**

**MES Project No. 7-121033**

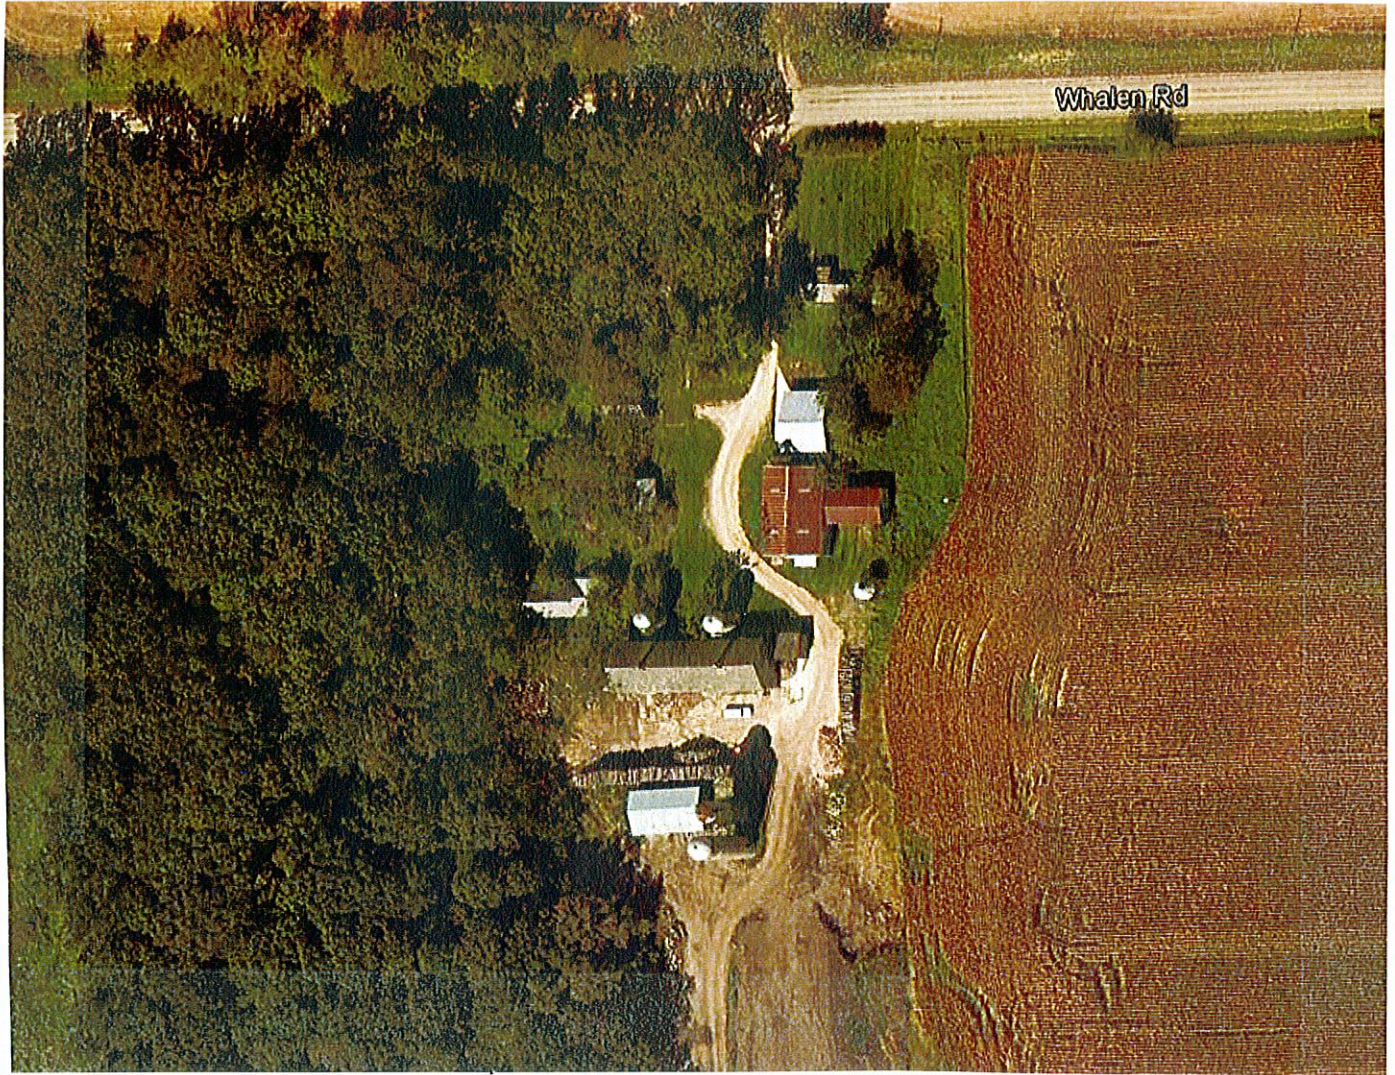
Figure 3

remaining parcels are occupied by a vacant farmstead (6661 Whalen Road), and a commercial structure (6620 CTH M). The farmstead area is shown on Figure 3. A description of the subject property, as observed during the MES site visit on September 19, 2012, is provided in the following paragraphs.

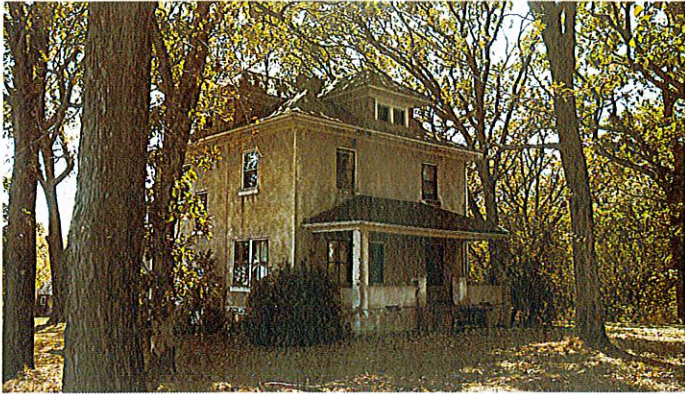
The vacant farmstead is generally located in the northwest portion of the property. It includes consists of eleven (11) structures, one corn crib and four (4) silos. The vacant farm house is located about 50 feet south of Whalen Road, and consists of a large two-story structure with a full basement. An old refrigerator, hot water heater, water pressure tank, several one to five-gallon paint containers, doors, some personal items, and a natural gas-fired furnace were observed in the basement. An approximate three-inch diameter pipe, which is similar in appearance to a fill pipe that might be associated with a former fuel oil tank, was observed extending into the basement in the general area where the air intake and exhaust pipes for the existing furnace are located. It appears that the house was formerly heated by a fuel oil-fired furnace and the tank was formerly situated within the basement. However, no tank was observed during the visit. The remainder of the house was generally vacant with some debris material through the house.

1. The photograph shows the vacant farm house.

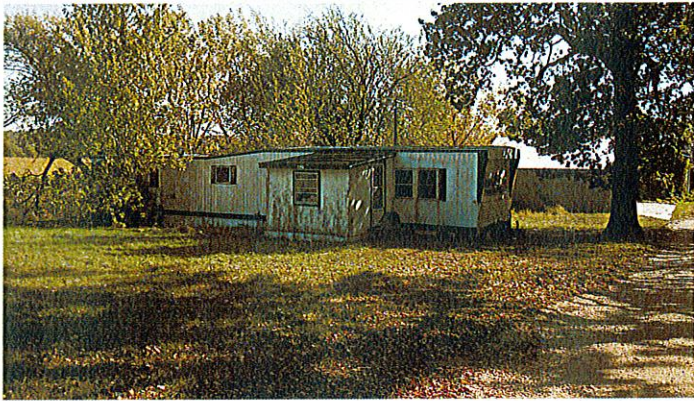
An abandoned mobile home is located to the east of the farm house. It does not have a lower basement level. An approximate 275-gallon fuel oil aboveground storage tank (AST), which appears to contain residual fuel oil for heating, was observed along the southern exterior wall line. No obvious evidence of staining or spillage was observed around this tank. Several old appliances, furniture, a furnace, and miscellaneous personal items and debris were observed in the mobile home.

2. Photograph shows the abandoned mobile home.

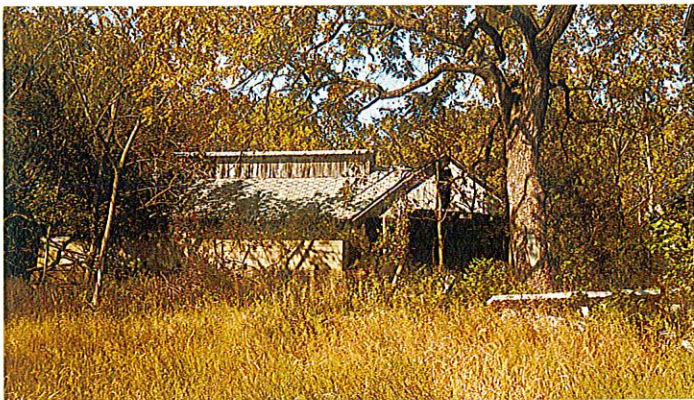
A two-story, wood-framed shed (that appeared to be a former calf barn) with a concrete floor is located to the northwest of large barn. A ceiling-mounted, propane gas-fired heating unit was observed in the eastern portion of the first level of this structure. It appears that a small diameter copper pipe was formerly connected to this unit. The pipe extended to the exterior and was observed at the ground surface near the southeast corner of the structure. The pipe is similar in appearance to those often used as fuel oil or propane supply lines. No obvious evidence of an underground storage tank (UST) was observed in the area. No obvious evidence of staining or significantly distressed vegetation was observed. Some miscellaneous items and debris was observed in the structure. It appears that this structure was originally used as a calf barn. An empty corn crib was observed to the north of this structure.

3. Photograph shows the vacant calf barn where the copper pipe was observed.

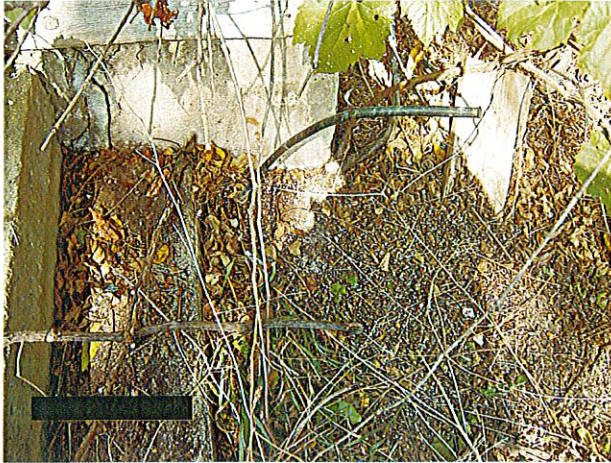
At the time of the site visit, a copper pipe was observed extending from the ground near the southeast corner of the calf barn. The observed copper pipe is similar to those often used as a product line for a propane tank or a fuel oil tank. It appeared that it was connected to a ceiling-mounted heater formerly used to heat the structure. However, it is unknown if the pipe was connected to a propane tank or a fuel oil tank. It is recommended that a limited exploration of the subsurface in this area of the site be performed to further evaluate the use of the pipe and the possible presence of a UST. This can be accomplished with a backhoe. If a tank is present, an evaluation of the potential for a past release to have occurred is also recommended.

4. Photograph shows the observed copper tube/pipe present near the calf barn.

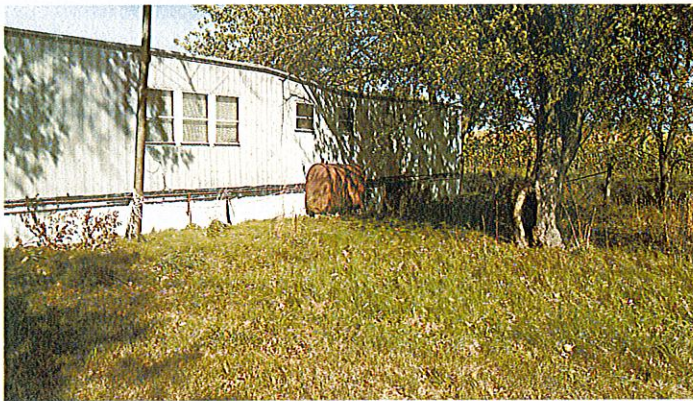
One (1) AST presently exists along the southern building line of the mobile home. The tank is similar to those typically used to store fuel oil, and may therefore have been used in the past as part of the heating system for the mobile home. Further, possible residual product appears to remain in the tank. If the AST is not to be utilized for future development, it is recommended that the residual product be removed and the tank be properly cleaned, removed and disposed of at an appropriate facility.

5. Photograph shows the AST near the mobile home.

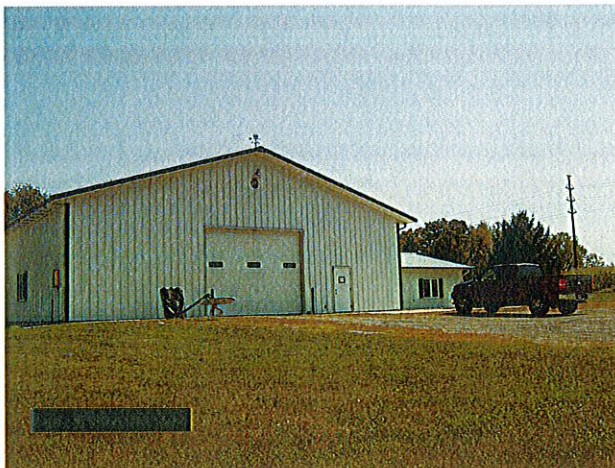
The commercial building (6620 CTH M) is generally located in the south-central portion of the property and immediately north of CTH M. The building is used for storage, some limited maintenance of vehicles, and offices. The office area was generally vacant. Several vehicles, a boat, numerous mounted heads of cape water buffalo, a snow mobile, power tools, a stove, varying-sized containers of paint and other miscellaneous personal items were observed in the storage area of the building. No significant spillage was observed around the containers. The structure is heated with a propane gas furnace and the propane is stored in an AST near the southeast building corner. An unheated structure is located to the north of the commercial structure. The northern end of this building was open. The building appeared to have been used for storage but was generally vacant. A concrete slab was observed to the north of the commercial structure and west of the unheated structure. No obvious evidence of staining or significantly distressed vegetation was observed in the area of this slab. This parcel is also serviced with private septic and a potable well.

6. Photograph shows the commercial building present in the south-central portion of the site.

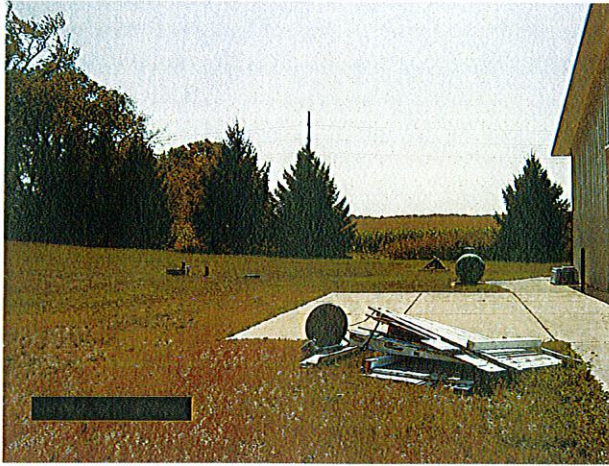
7. Photograph shows the existing propane tank and septic system present on the commercial parcel.

The site is serviced by private septic systems. Septic systems can provide a conduit for contaminants to infiltrate surficial and deeper drinking water aquifers. If the septic system is not to be used in the future, it is recommended that it be abandoned in accordance with any local specifications.

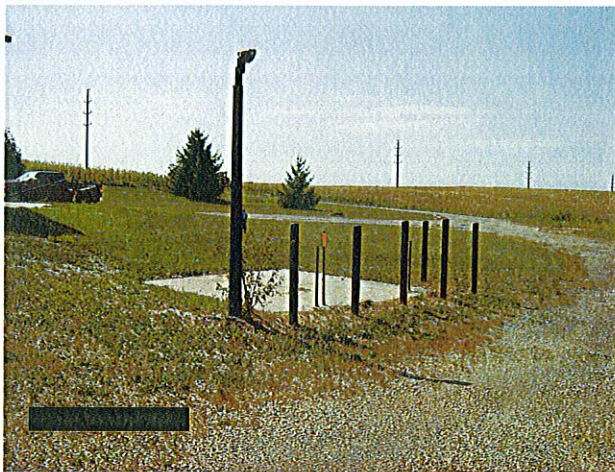
The report indicated that two (2) double-walled ASTs were present on the existing concrete slab. URS stated that the tanks consisted of a 550 gallon diesel fuel tank and a 1,000 gallon unleaded gasoline tank. URS did not indicate if staining or spillage was observed around this slab. However, they stated that the property owner, Mr. Robert Darrow, was planning on removing these tanks at the time of the property transaction. The URS report concluded that they did not identify any recognized environmental conditions (RECs) associated with the 12 acre commercial property.

8. Photograph shows the concrete slab present on the commercial parcel.

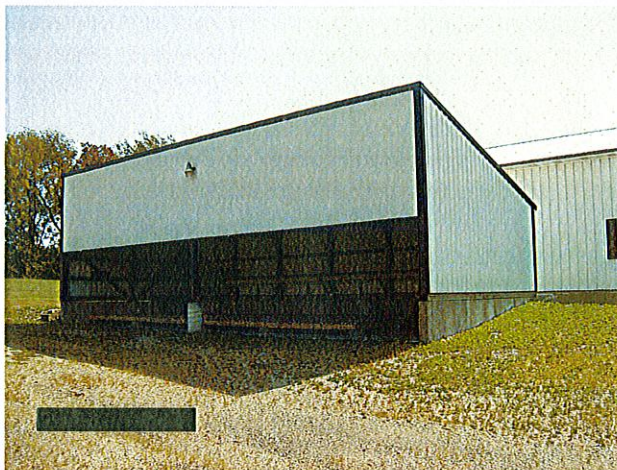
9. Photograph shows the storage structure present on the commercial parcel.

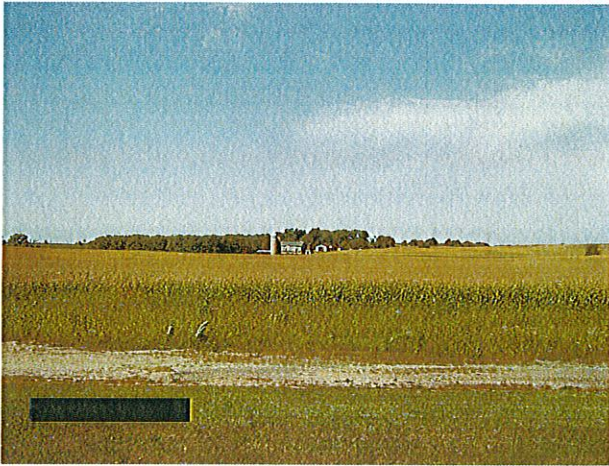
10. Photograph taken from the commercial parcel and facing to the northwest. The abandoned farmstead is shown in the background.

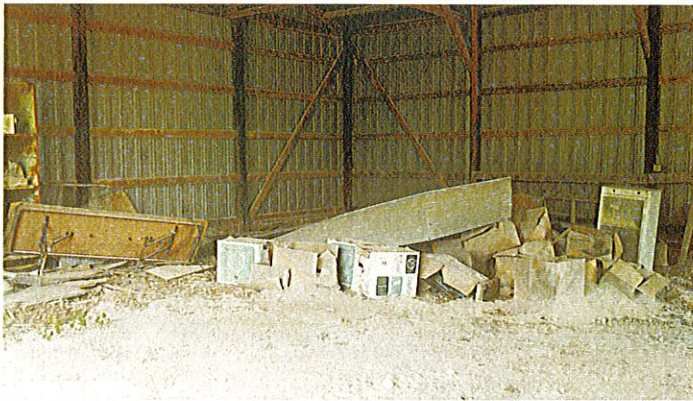
11. Photograph shows personal items and debris observed in one of the farmstead structures.

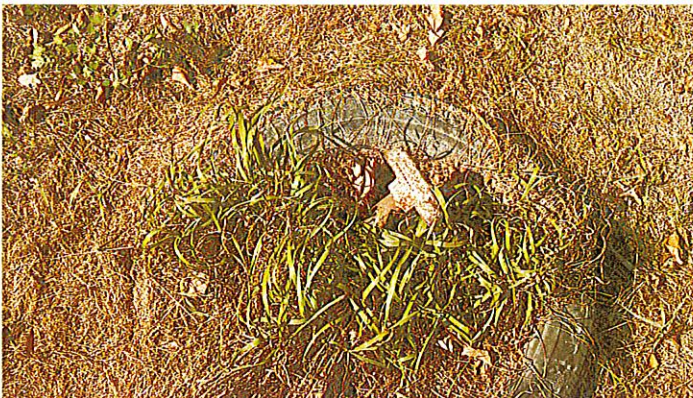
Typical vent pipes associated with private septic systems were observed near the farm house and mobile home. A vent pipe was observed south of the farmhouse and was similar in appearance to vent pipes often associated with a UST or AST. However, the pipe appeared to be loose and not attached to anything in the subsurface. Additionally, a fill pipe or dispenser typically associated with a UST was not observed in the area. The farmstead is serviced with a private potable well.

At the time of the site visit, a pipe of unknown origin was observed protruding from the ground surface south of the farm house. The pipe is somewhat similar to those often used as a vent pipe for underground storage tanks. However, as indicated, the past or present use of the pipe could not be ascertained at the time of the site visit and it also appeared not be connected to anything. It is recommended that a limited exploration of the subsurface in this area of the site be performed to further evaluate the use of the pipe and the possible presence of a UST. This can be accomplished with a backhoe. If a tank is present, an evaluation of the potential for a past release to have occurred is also recommended.

12. Photograph shows the apparent vent pipe observed to the south of the farmhouse.

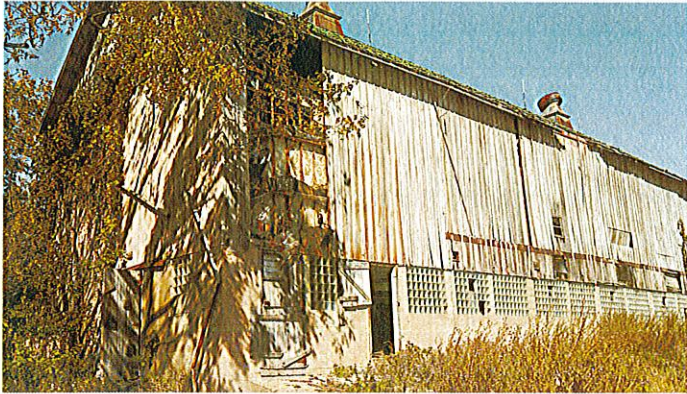
A large two-story wood-framed barn with a lower level milking parlor with a concrete floor is located near the center of the farmstead. It did not appear to have been heated in the past. Several tires, old electronics, car parts, electric motors, lumber, hay bales, and miscellaneous wood and metal items and debris were observed in the barn. No obvious evidence of spills or

13. Photograph shows the southern side of the large barn.

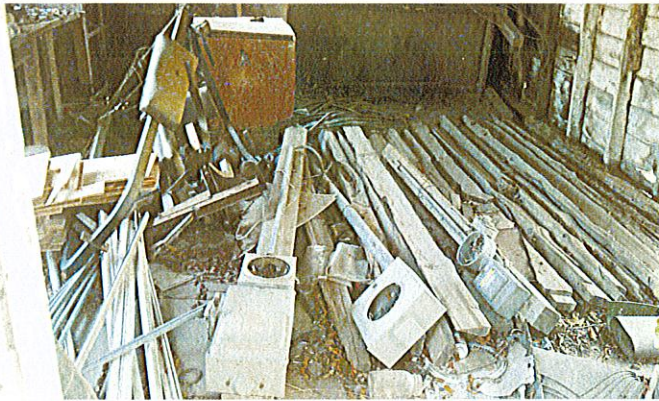
Several one to two-story, wood-framed sheds with a concrete floor are located generally to the south to southwest of the farm house. Windows, screens, furniture, numerous electrical circuit boxes, electrical conduits, electrical fuses, light fixtures, heat ducts, hot water heaters, wood molding, several tires, a few empty gasoline containers, electrical items, exercise equipment, shingles, miscellaneous items, and wood and metal debris were observed in and around this structure. It did not appear that these structures were heated in the past.

14. Photograph shows electrical material present in one of the farmstead buildings.

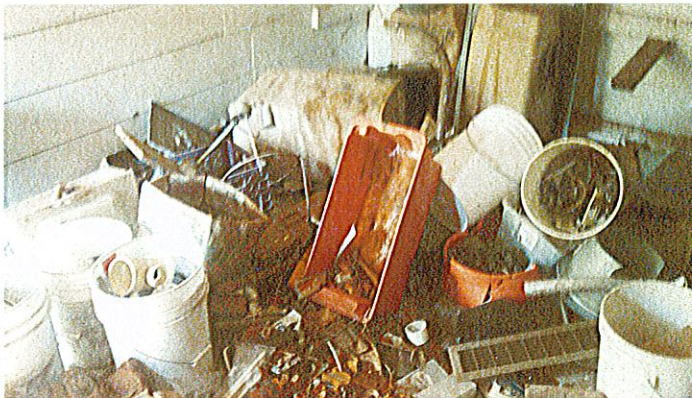
15. Photograph shows personal items and debris observed in one of the farmstead buildings.

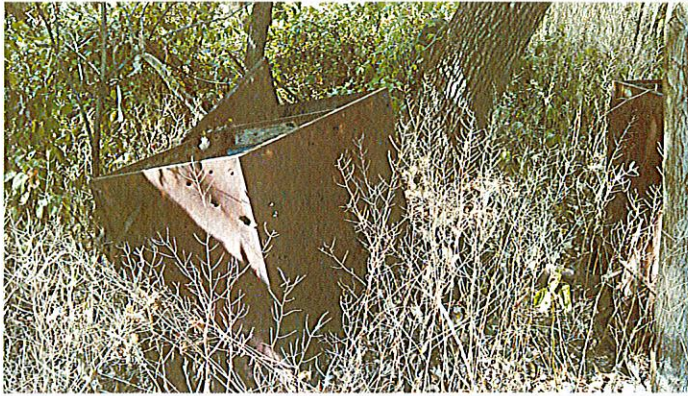
The remainder of most of the property was vacant rolling agricultural land. Wooded areas were observed in the northwest corner of the site, immediately west of the farmstead and in the southeast portion of the site, east of the commercial building. Small to large trees, brush, rock piles with some debris were observed along the existing field fence lines. In addition, wooden farm equipment, metal debris, barbed wire, a few empty metal drums, plastic items, cobbles and large boulders and miscellaneous debris, were observed within the wooded area

16. Photograph shows debris observed in the wooded area near the farmstead.

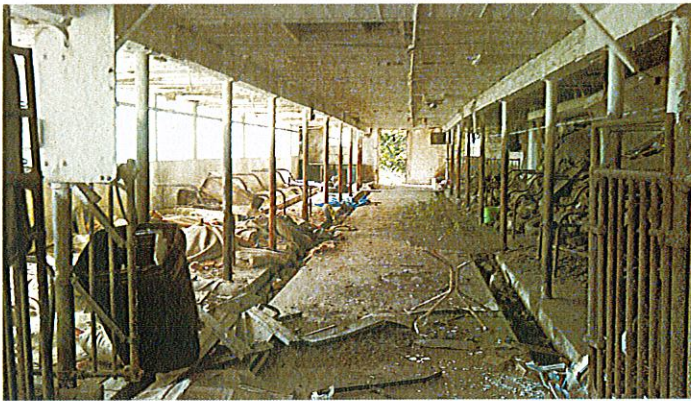
17. Photograph shows the former milking parlor in the large barn.

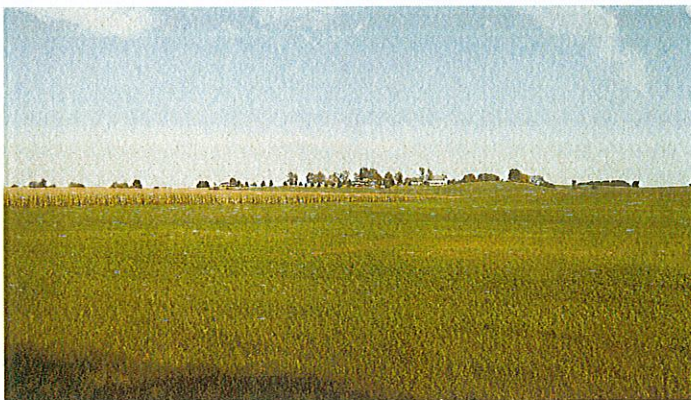
18. Photograph shows a portion of the agricultural land present on the subject site.
