Phase I Environmental Site Assessment Beaver Dam Industrial Site

Project I.D.: 18A005.02

**Alliant Energy
Madison, WI**

October 2018

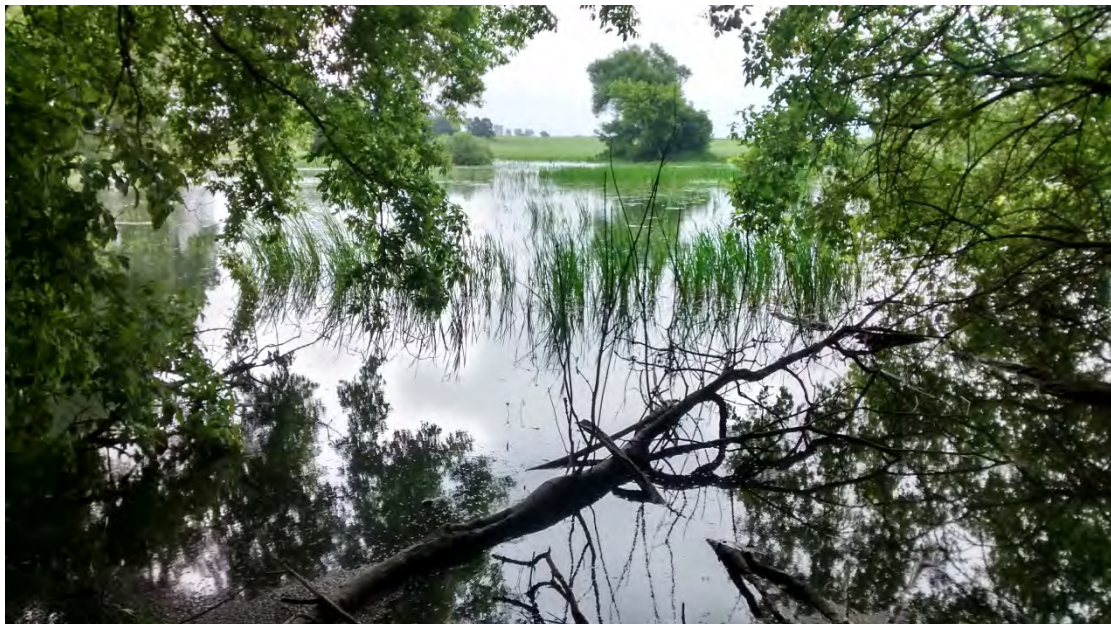
Photo No. 1	Date: 6/20/18

Direction Photo Taken: Northeast		
Photo Taken By: Katie Goff		
Description: Wetland area near south project boundary. Parcel 1533-000

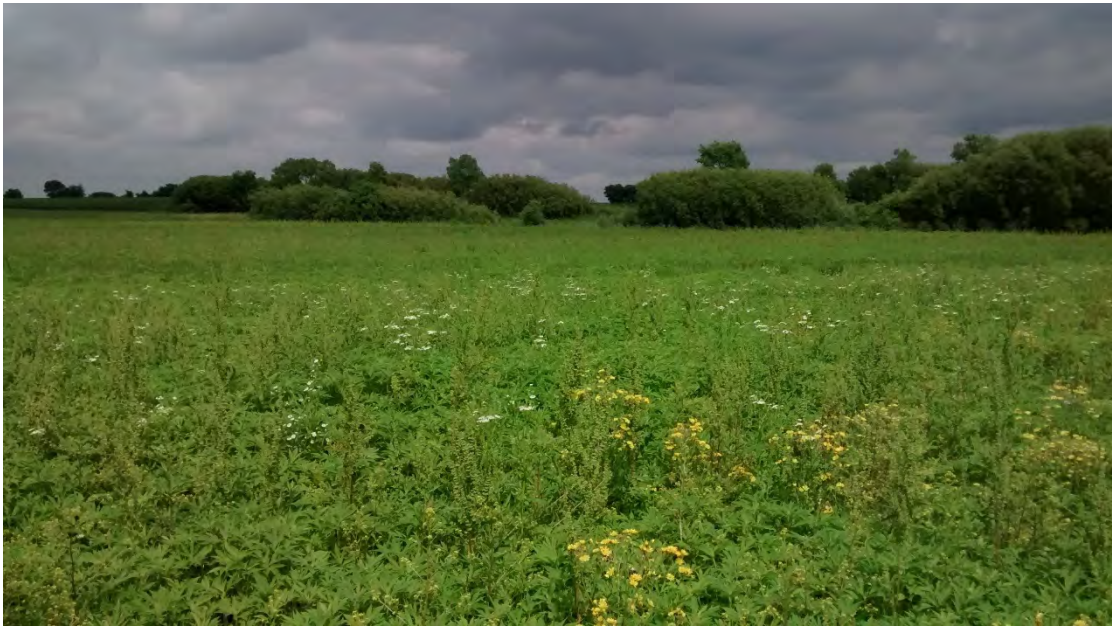
Photo No. 6	Date:

Direction Photo Taken: East		
Photo Taken By: Katie Goff		
Description: Wetland area in central portion of property. Parcel 1523-00

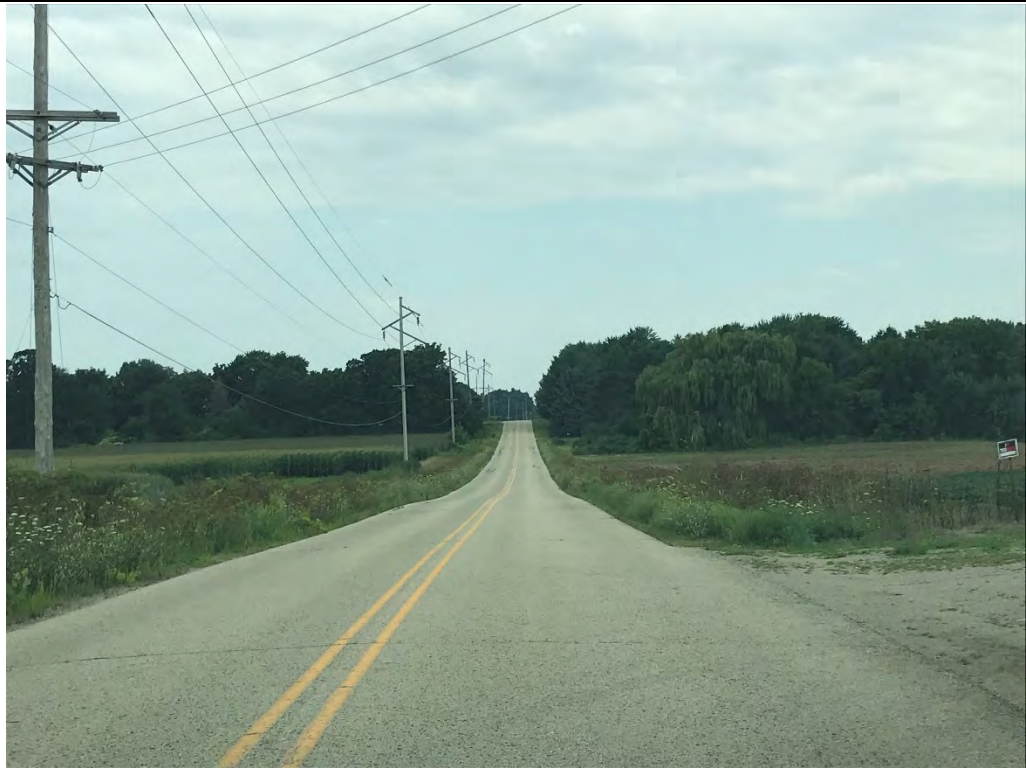
Photo No. 38	Date: 8/10/18

Direction Photo Taken: West		
Photo Taken By: Katie Goff		
Description: Hemlock Road along south boundary of property.

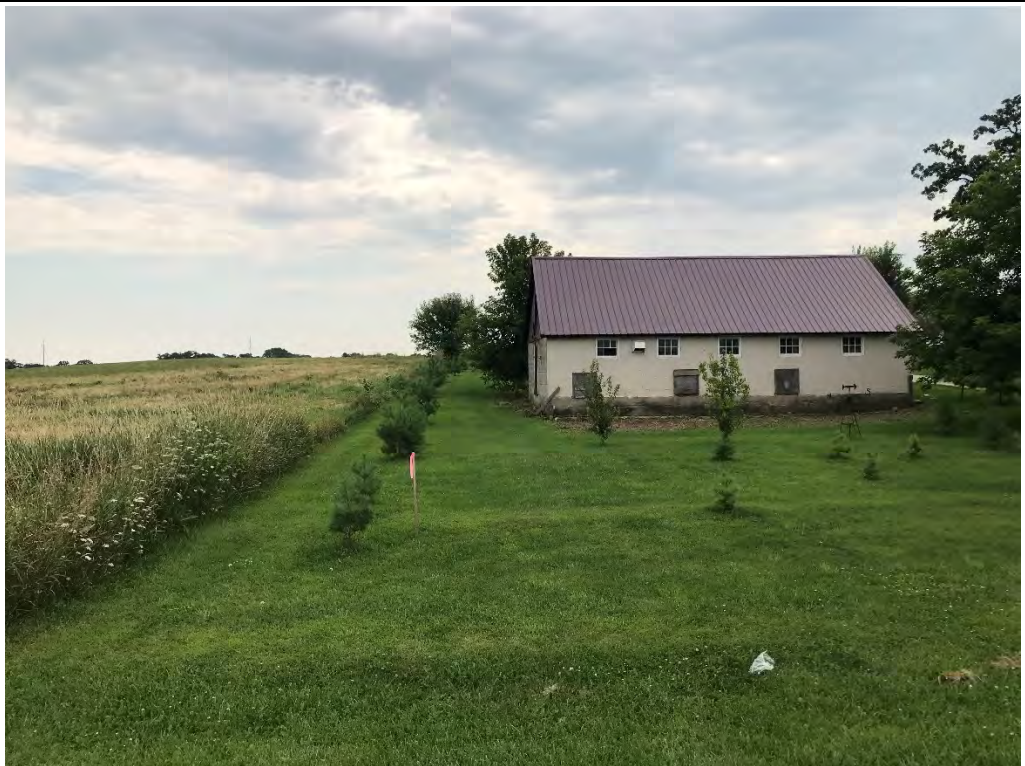
Photo No. 43	Date: 8/10/18

Direction Photo Taken: East		
Photo Taken By: Katie Goff		
Description: Residence along west and south property boundary, east of County Road W
